8. Troubleshooting

8.1 Procedure of Checking the Symptoms

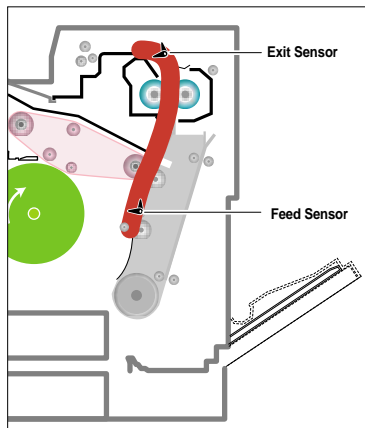
8.3.3 JAM1(JAM inside pinter)

Symptoms Paper is jammed in front of the Fuser or under the T2 Roller.

Check and Cause	Solution
<ol style="list-style-type: none"> 1. If the paper is jammed in front of or inside the Fuser 2. If the paper is caught in the Exit Roller and the Fuser check the Feed Sensor actuator opens and closes freely. 	<ol style="list-style-type: none"> 1. Replace the SMPS. 2. - Re-assembly the Feed Actuator and Spring, or clean the Hinge with a lint free cloth. - Replace the Main PBA.

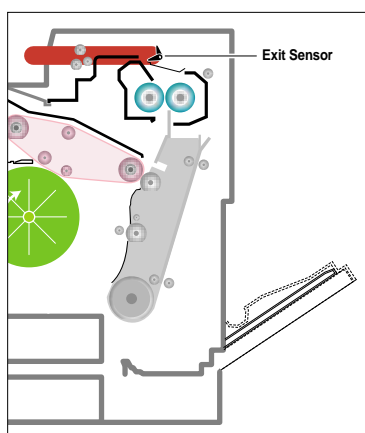
8.3.4 JAM 2 (Jam in Exit Area)

Symptoms

1. Paper is jammed inside the Fuser.
2. Paper is caught in the Exit Sensor Actuator.
3. Paper is caught in the Exit Roller and Fuser, after passing through the Feed Sensor actuator

Check and Cause	Solution
<ol style="list-style-type: none"> 1. The Exit Sensor is defective if Jam 2 occurs after the paper is completely fed out of the printer. This can happen if the actuator sticks open or is slow to close. 2. Paper is rolled into the Fuser. <ul style="list-style-type: none"> • “Accordion” folding occurs repeatedly. • Fuser temperature is too high due to failure or other abnormal conditions. • If the Heat Roller or Pressure Roller is contaminated hard because of Toner. 3. If there are “Accordion” paper folds inside the Fuser. 4. If the Exit Sensor is defective. a Jam In Exit Area will occur and printing will stop. 	<ol style="list-style-type: none"> 1. Check if the Exit Sensor Actuator is broken or damaged. <ul style="list-style-type: none"> • Check if the Exit Sensor Actuator is deformed (Check that the sensor arms are not deformed). • Check for Burrs or rough edges in the Exit Actuator assembly, and check that the sensor arms are free to move. • Check for foreign objects obstructing the Exit actuator. 2. Replace the Fuser. 3. • Replace the Exit Guide. <ul style="list-style-type: none"> • Check that the Exit unit is assembled properly and full functioning and replace if necessary. 4. Replace the Exit Sensor.

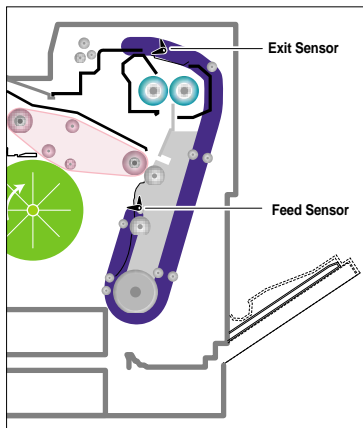
8.3.5 JAM Duplex

Symptoms Indicated "Jam in Duplex Area" on the LCD indicator.

Check and Cause	Solution
<ol style="list-style-type: none"> 1. Paper in the duplex path fails to operate the Feed Sensor. 2. Paper in the duplex path fails to reach the Feed Sensor because of jamming in the Duplex Path. 	<ol style="list-style-type: none"> 1. Replace the Feed Sensor or Exit Sensor. 2. Check that there are no foreign objects or fragments of paper in the Duplex Path. If necessary replace the Duplex Unit.
